**Flood Control Project Maintenance
Levee Inspections**

Fall 2019 Levee Maintenance Deficiency Summary Report

Sacramento River Basin

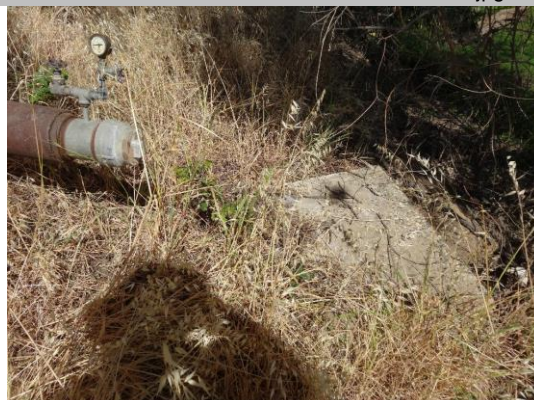
Photo 2 of 3 : UCIP_FA_2019_41673_22744.jpg

Comment Code						
Inspector Comment						
DS_ID:22536 FS_ID:41673 EP_NO: 5562 Repair Type: Non-Urgent Crossing Status: Found UCIP Comments: 05/23/2013 Pipe appears abandoned and if so should be done so properly. WS pipe plugged with stopper. Seems abandoned. Only abandoned pump base found. (P. Amatya - DWR UCIP) FIELD_STRUCT_DESC: 6-inch coated steel irrigation pipe through the levee, 3.5 feet below the crown. Metal cutoff collar placed on the pipe at the center of the levee crown. Pump was removed. Pump base on the waterside (WS) berm. Shutoff valve on the discharge side of the pump. Foot valve below water on the intake side of the pump. Siphon breaker on the landside (LS) shoulder. Pipe discharges into underground irrigation system on the LS. Power pole and meter box, 10 feet from the landward toe. 1.5-inch flexible conduit through levee, 3.5 feet below the crown. (Pump and 6-inch irrigation pipe authorized under Permit No. 5562, 1966 - Samuel B. Single). [Additional Reference(s): DWR Levee Log, 1993]. FS Date: 5/23/2013

WS- plugged pipe and pump base.

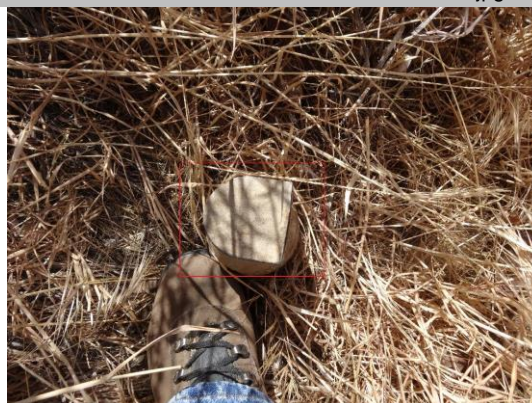
Photo 3 of 3 : UCIP_FA_2019_41673_22743.jpg

LS- only pipe air vent found on levee slope.

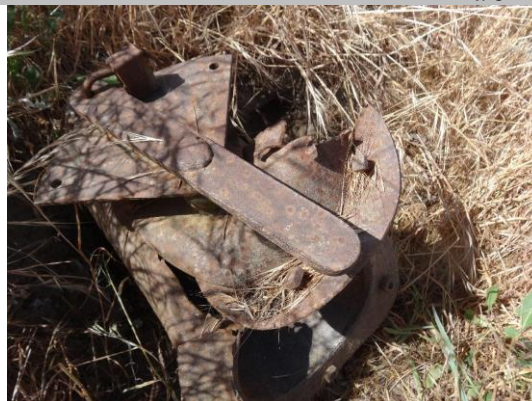
Photo 2 of 3 : UCIP_FA_2019_50740_22752.jpg

DS_ID:22529
FS_ID:50740
EP_NO: 2281
Repair Type: Non-Urgent
Crossing Status: Not Found
UCIP Comments: 01/17/2019 Records detailing the actions taken for the removal of the 7-inch pipe were recorded under file name LI10703_79259 document 20141008 CVFPB letter of acknowledgement available through permit records. (O. Magana - DWR UCIP)
07/13/2016 According to district president Joe Henderson, pipe was removed 2-3 years ago. No permit for removal found or evidence of pipe or its removal found. (K. Fazel - UCIP)
05/23/2013:- leaky pipe end and erosion on WS.- cracked dirt mound on LS - seems not been used for some time. (P. Amatya - DWR)
FIELD_STRUCT_DESC: *REMOVED* 7-inch steel irrigation pipe through the levee, 1.9 feet below the crown. Portable pump mounted on the bank during the summer months. Control valve on the waterside (WS). Steel plate bolted on the WS end during the winter months. Pipe discharges into a 30-inch concrete standpipe at the landside (LS) toe. (Pump and 7-inch irrigation pipe authorized under Permit No. 2281, 1956 - Willard R. Brown; 7-inch pipe through levee and concrete standpipe located on LS were removed as part of the 2013 USACE Periodic Inspection). [Additional Reference(s): DWR Levee Log, 1993].

WS- seems abandoned or not been used for some time.

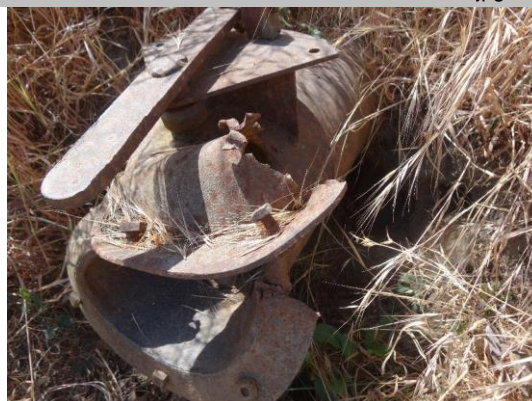
Photo 3 of 3 : UCIP_FA_2019_50740_22751.jpg

WS- due to water leak, soil around pipe eroded.

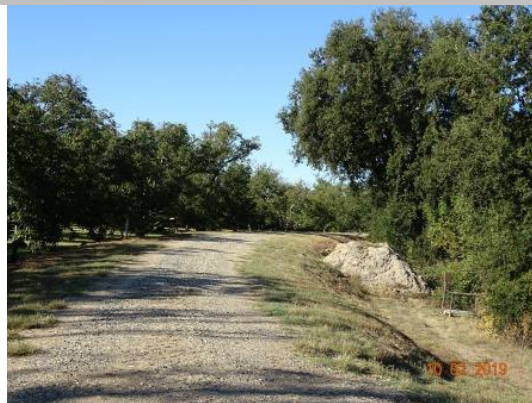
Photo 1 of 1 : FA_2019_RD1001_35_12_20191029_00028.jpg

View of a pile of soil on the waterside slope looking downstream, Fall 2019.

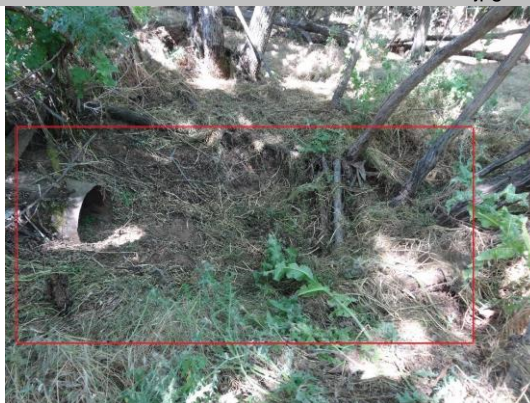
Photo 2 of 3 : UCIP_FA_2019_14128_23307.jpg

LM Start	0.88	Rating **	M	Issue No.	911	
LM End	0.88	Issue Type +	En	Location *		
Category	Supplemental			GPS Latitude/Longitude		
				Start	End	
Item	DRAFT DWR UCIP Field Study			39.006508 °	39.006508 °	
				-121.391086 °	-121.391086 °	
DWR ID	22549					
Comment Code						
Inspector Comment						
DS_ID:22549						
FS_ID:14128						
EP_NO: 958						
Repair Type: Non-Urgent						
Crossing Status: Found						
UCIP Comments: 05/21/2013 - slide gate on WS not found- needs abandoned properly. (P. Amatya - DWR UCIP)						
FIELD_STRUCT_DESC: *ABANDONED* 24-inch irrigation pipe of an unknown material through the levee, at an unknown depth. Slide gate on the waterside (WS) end. (24-inch irrigation pipe authorized under Permit No. 958, 1944 - Frank B. Lichty and Maggie Lichty).						
FS Date: 5/21/2013

WS- abandoned CMP and depression around it.

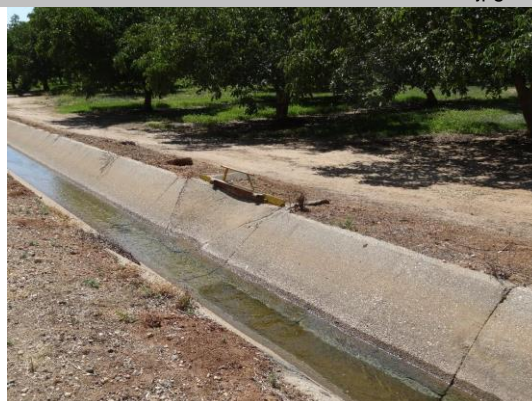
Photo 3 of 3 : UCIP_FA_2019_14128_23309.jpg

LS- no pipe or structure found on landside.

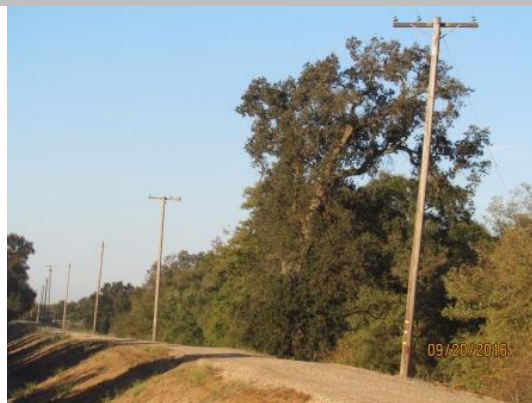
Photo 1 of 1 : FA_2019_RD1001_37_3_20190904_00001.jpg

LM Start	1.16	Rating **	M	Issue No.	3
LM End	1.78	Issue Type +	En	Location *	WS
Category	Earthen Levee			GPS Latitude/Longitude	
				Start	End
Item	Encroachments			39.005730 °	38.999534 °
				-121.396111 °	-121.404395 °
DWR ID	DWR_RD1001_03_s_2012_3				
Comment Code					
PO : Pole					
Inspector Comment					
Unpermitted Power Poles on the crown along waterside shoulder.

View of Power Poles along waterside shoulder.

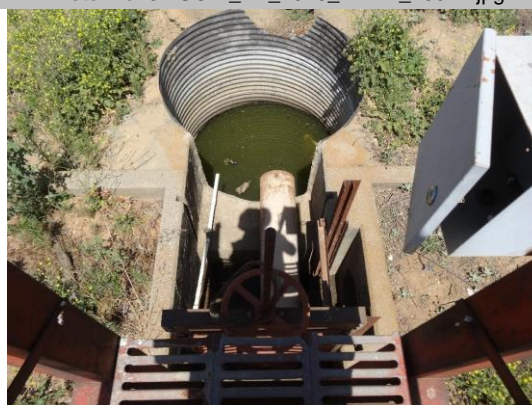
Photo 2 of 3 : UCIP_FA_2019_41727_23324.jpg

Comment Code						
Inspector Comment						
DS_ID:22561 FS_ID:41727 EP_NO: 4505 Repair Type: Non-Urgent Crossing Status: Found UCIP Comments: 05/21/2013 Two small steel pipes sleeved through 30-inch CMP may be a compliance issue as slide gate cannot close.- this may have been converted into drainage pipe (?) - big CMP standpipe on WS. (P. Amatya - DWR UCIP) FIELD_STRUCT_DESC: 30-inch concrete encased corrugated metal irrigation pipe through the levee, 11 feet below the crown. Concrete headwall and slide gate at the waterside (WS) toe, removed. Metal walkway on the WS to the slide gate. Pipe discharges into a 48-inch concrete standpipe at the landside (LS) toe. Two vertical pumps. (30-inch concrete encased corrugated metal irrigation pipe authorized under Permit No. 4505, 1964 - State of California, Department of Public Works, Division of Highways). [Additional Reference(s): DWR Levee Log, 1993. USACE Sacramento O&M Manual 141.1, August 1955, (Station 949+00), 30-inch steel pipe referenced]. FS Date: 5/21/2013

WS- CMP standpipe, pipes and concrete headwall.

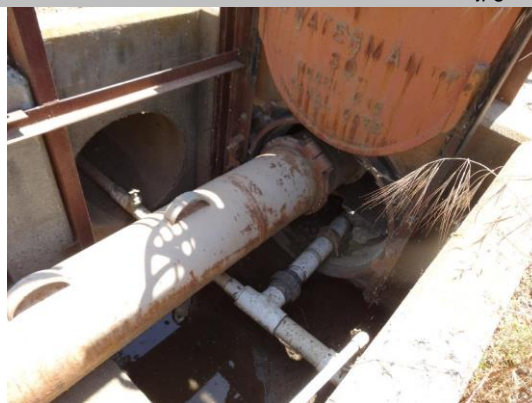
Photo 3 of 3 : UCIP_FA_2019_41727_23323.jpg

WS- two steel pipes are sleeved through 30-inch CMP.

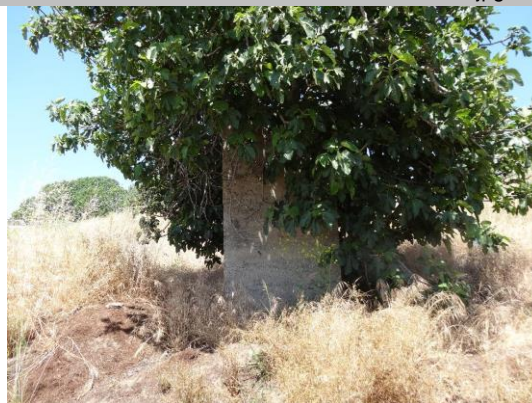
Photo 2 of 2 : UCIP_FA_2019_41722_23337.jpg

LS- a big tree inside concrete standpipe.

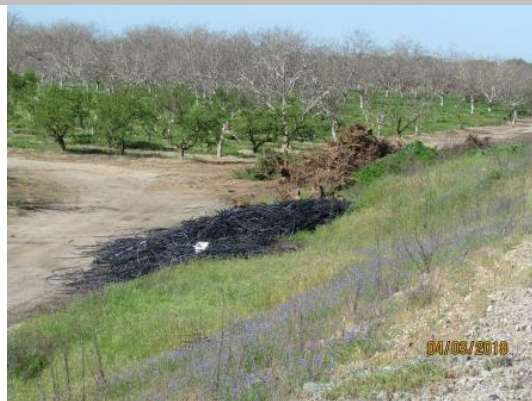
Photo 1 of 1 : FA_2019_RD1001_37_35_20190904_00023.jpg

View looking downstream landside of drip irrigation and trash still on levee slope.

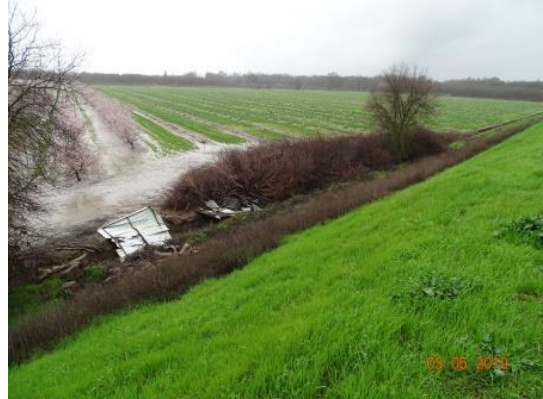
Photo 1 of 1 : FA_2019_RD1001_37_14_20190904_00010.jpg

View looking downstream landside at debris that has been piled up on the levee toe.

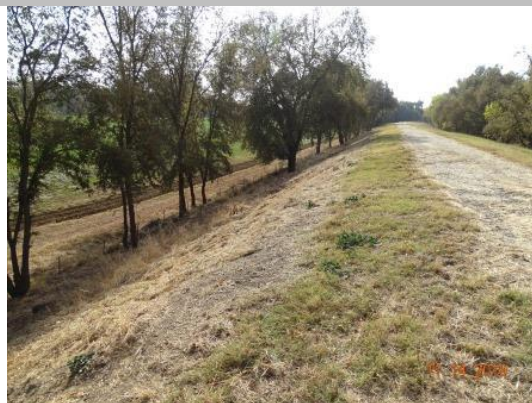
Photo 1 of 1 : FA_2019_RD1001_38_55_20191118_00075.jpg

View looking downstream landside at the well maintained annual vegetation, Fall 2019.

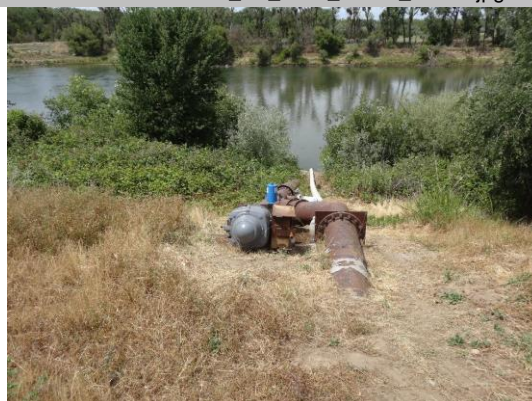
Photo 1 of 3 : UCIP_FA_2019_55167_24121.jpg

WS- slanted pump and pipe on levee slope.

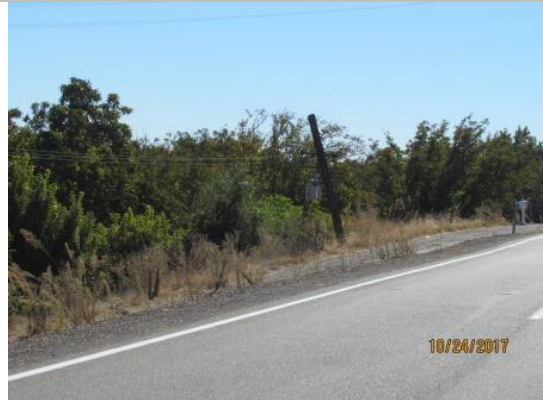
Photo 1 of 1 : FA_2019_RD1001_38_27_20190904_00011.jpg

LM Start	5.71	Rating **	M	Issue No.	27
LM End	5.71	Issue Type +	En	Location *	LS
Category	Earthen Levee			GPS Latitude/Longitude	
				Start	End
Item	Encroachments			38.874984 °	38.874984 °
				-121.614242 °	-121.614242 °
DWR ID	DWR_RD1001_04_s_2015_27				
Comment Code					
PO : Pole					
Inspector Comment					
Remove pole on levee slope.

View of pole on landside, no lines connected to it.

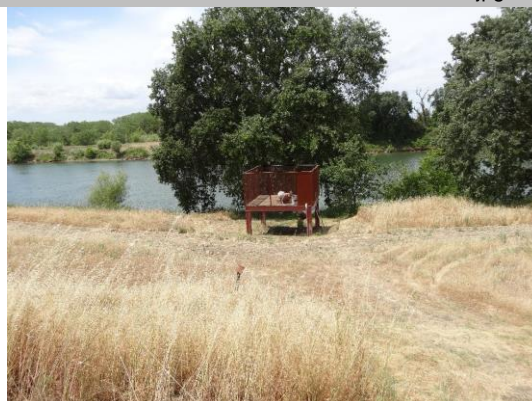
Photo 1 of 3 : UCIP_FA_2019_55170_24107.jpg

WS- slanted pump station on steel platform on levee berm.

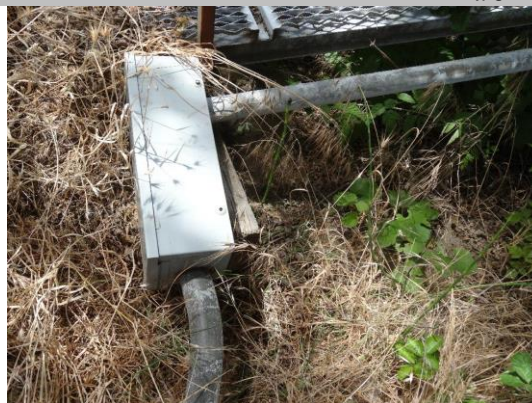
Photo 2 of 3 : UCIP_FA_2019_55172_24064.jpg

WS- power cable also penetrates the levee. Power cable box near steel walkway

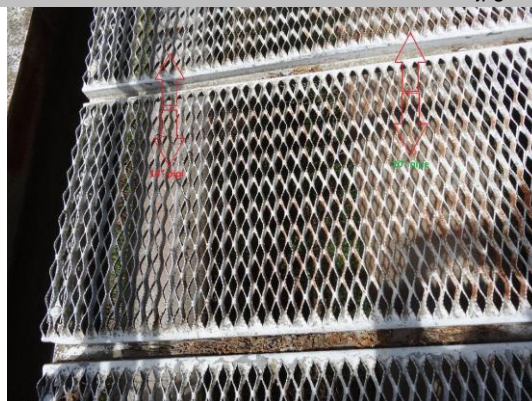
Photo 3 of 3 : UCIP_FA_2019_55172_24063.jpg

WS- pipes visible through steel walkway deck.

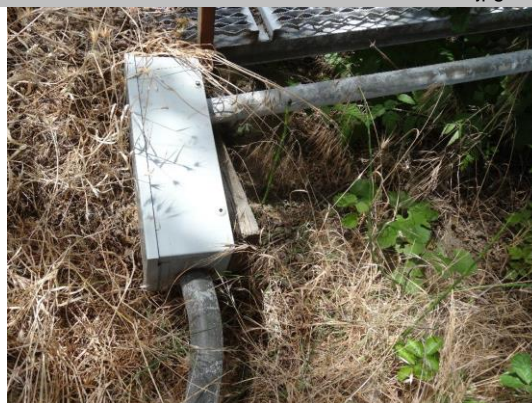
Photo 2 of 3 : UCIP_FA_2019_55173_24069.jpg

WS- power cable near steel walkway. Power cable penetrates through the levee.

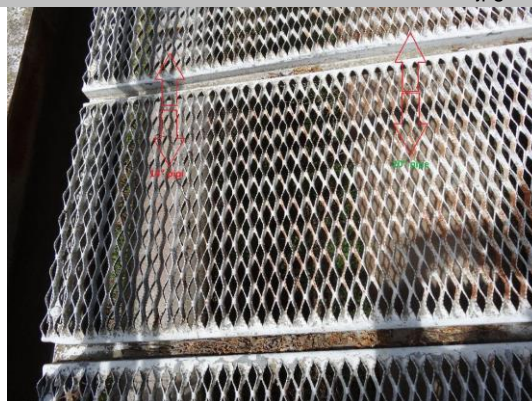
Photo 3 of 3 : UCIP_FA_2019_55173_24068.jpg

WS- steel pipes visible through steel walkway.

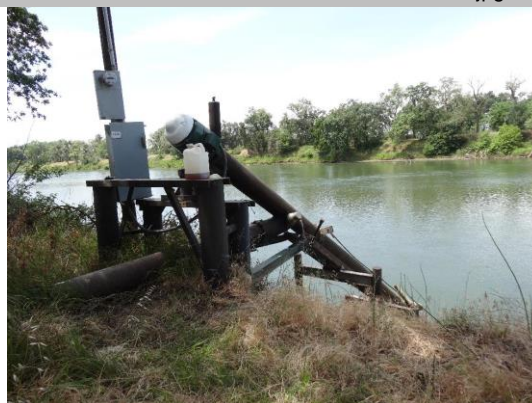
Photo 1 of 3 : UCIP_FA_2019_55174_24041.jpg

WS- slanted pump station, pipe, power pole on river bank.

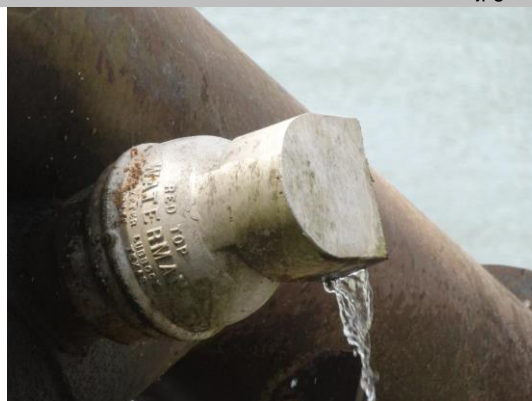
Photo 2 of 3 : UCIP_FA_2019_55174_24040.jpg

WS- water leaking from air vent on inlet pipe.

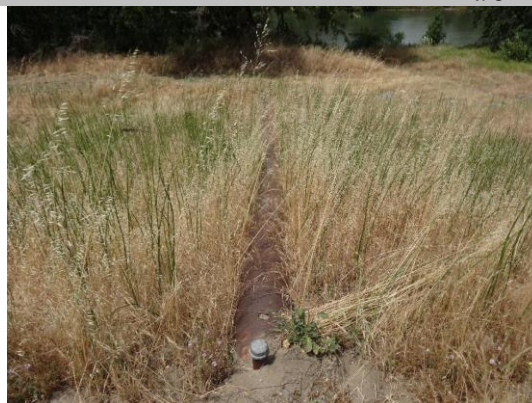
Photo 3 of 3 : UCIP_FA_2019_55174_24044.jpg

WS- steel pipe exposed on levee slope.

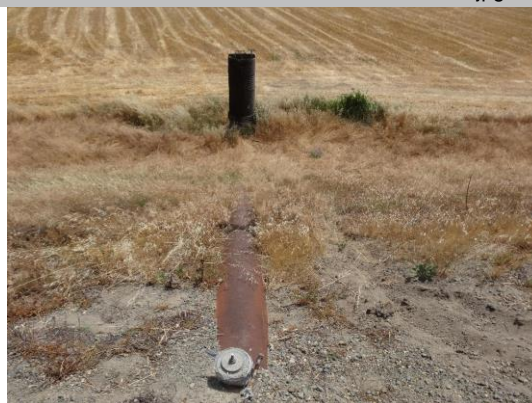
Photo 3 of 3 : UCIP_FA_2019_55175_24031.jpg

LS- siphon breaker, exposed steel pipe, and CM standpipe on landside.

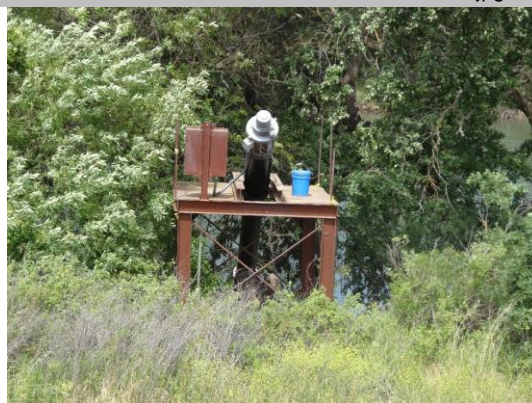
Photo 1 of 3 : UCIP_FA_2019_55177_24002.jpg

WS- slanted pipe in steel structure on river bank.

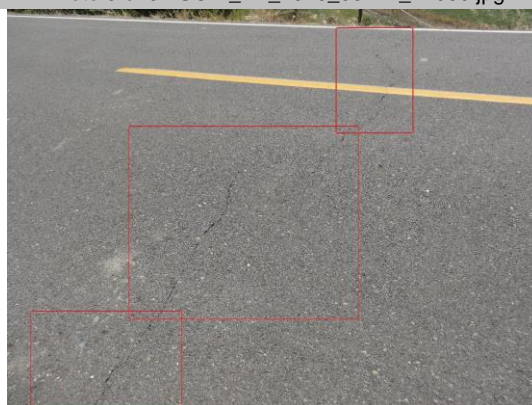
Photo 3 of 3 : UCIP_FA_2019_55177_24000.jpg

Levee Crown- road surface cracks along the pipe. Needs more investigation.

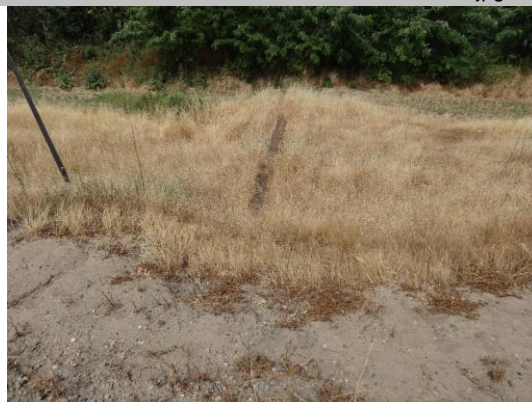
Photo 1 of 3 : UCIP_FA_2019_55178_23966.jpg

WS- damaged pipe with holes, cracks on levee slope. River bank is not visible due to dense vegetation (top)

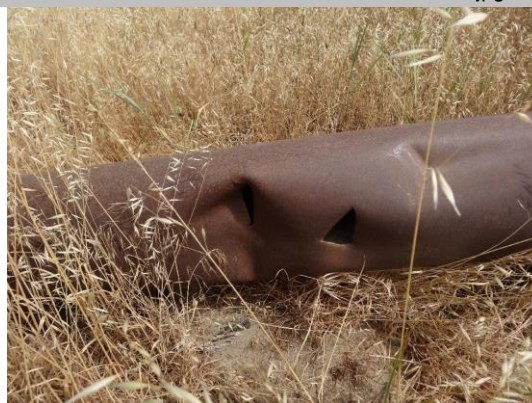
Photo 2 of 3 : UCIP_FA_2019_55178_23965.jpg

WS- abandoned damaged pipe with holes, cracks on levee slope.

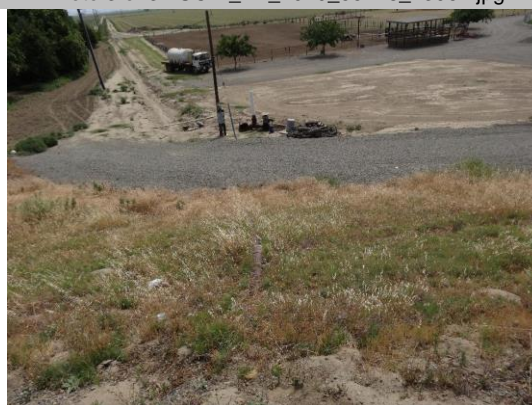
Photo 3 of 3 : UCIP_FA_2019_55178_23964.jpg

LS- overview of landside, steel pipe on levee slope.

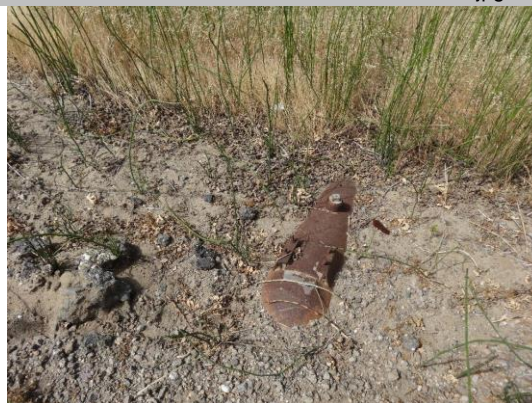
Photo 2 of 3 : UCIP_FA_2019_55179_24133.jpg

WS- exposed pipe on levee slope.

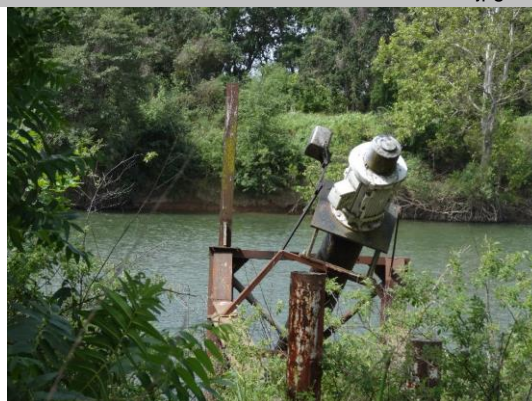
Photo 3 of 3 : UCIP_FA_2019_55179_24132.jpg

WS- abandoned slanted pump station in steel pipe structure in river bank.

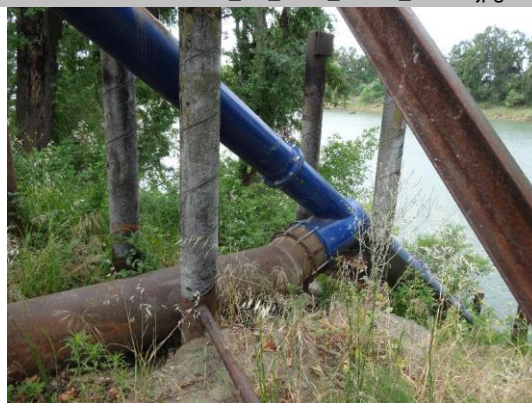
Photo 2 of 3 : UCIP_FA_2019_55180_23976.jpg

WS- main steel pipe on levee surface (without paint).

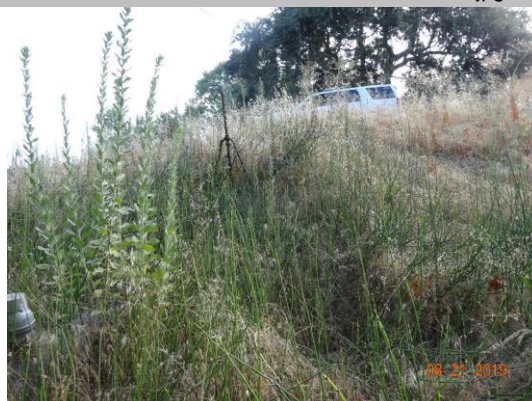
Photo 3 of 3 : UCIP_FA_2019_55180_81186.jpg

WS view: limited visibility to evaluate pipe crossing through levee section.

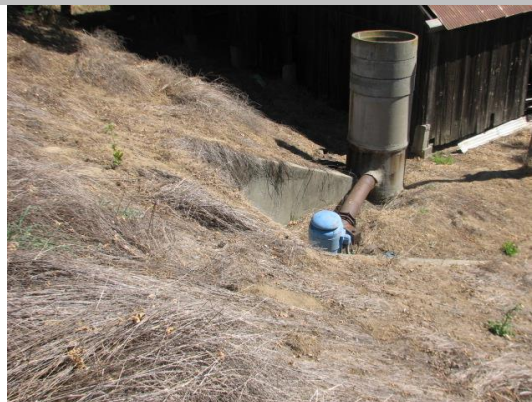
Photo 1 of 1 : FA_2019_RD1001_38_30_20190904_00014.jpg

A retaining wall is within the profile of the slope.

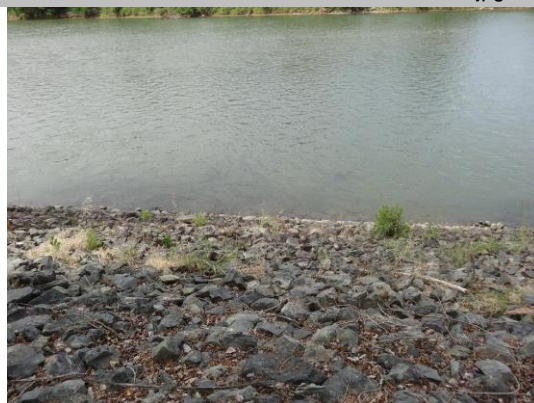
Photo 1 of 3 : UCIP_FA_2019_55181_23974.jpg

WS- no pipe or structure found.

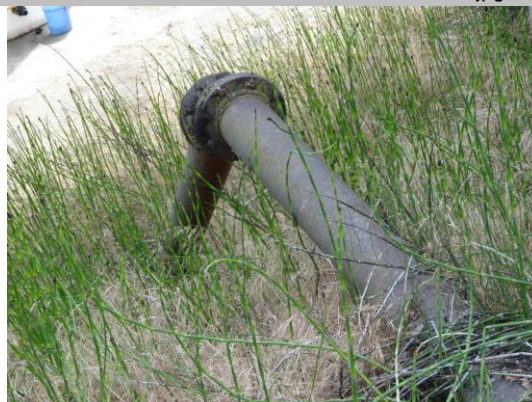
Photo 3 of 3 : UCIP_FA_2019_55181_23975.jpg

LS- portion of steel pipe exposed in levee slope.

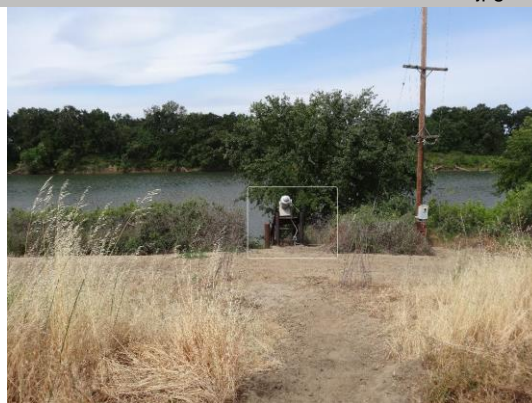
Photo 1 of 3 : UCIP_FA_2019_55966_23970.jpg

WS- slant pump on river bank.

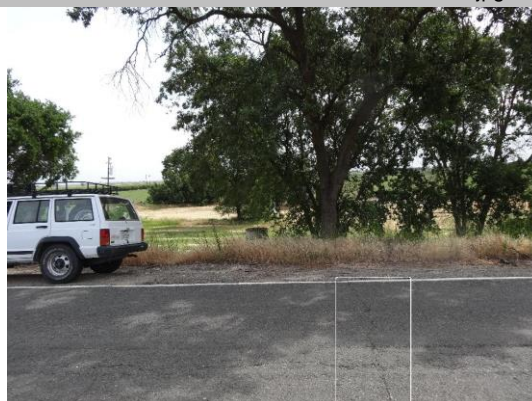
Photo 2 of 3 : UCIP_FA_2019_55966_23969.jpg

Levee Crown- surface crack along pipe crossing. Needs more investigation.

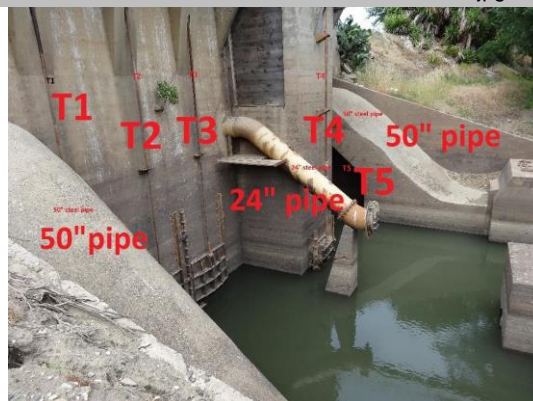
Photo 3 of 3 : UCIP_FA_2019_14393_23799.jpg

WS- three steel pipes inside tunnel. Fifty inch pipes on left and right. Twenty four inch pipe in middle of the structure as shown.

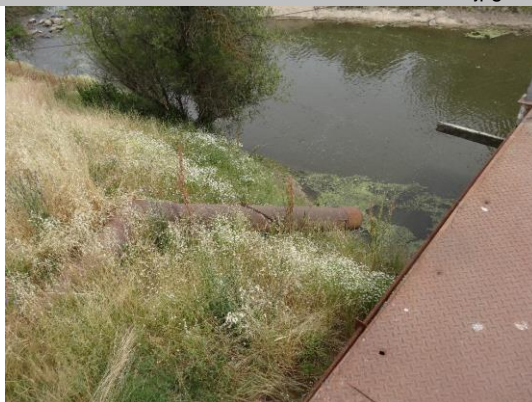
Photo 2 of 3 : UCIP_FA_2019_14486_23912.jpg

WS- abandoned pipe adjacent to pump station on stream bank.

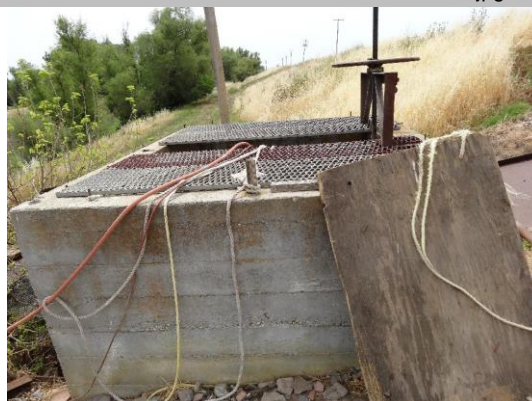
Photo 3 of 3 : UCIP_FA_2019_14486_23911.jpg

WS- slide gate in concrete box on levee toe.

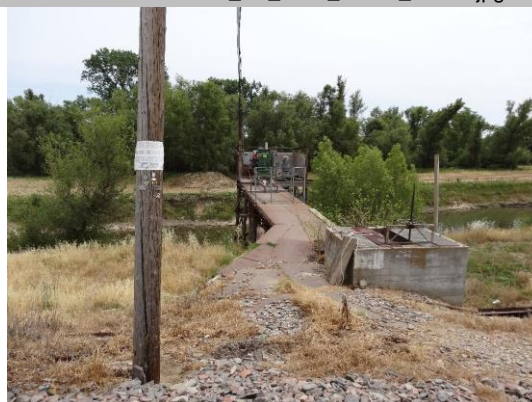
Photo 1 of 3 : UCIP_FA_2019_14484_23894.jpg

WS- overview of pump station, walkway, and slide gate in concrete box.

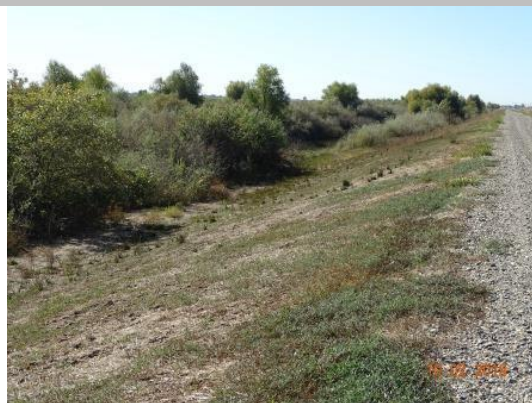
Photo 1 of 1 : FA_2019_RD1001_40_26_20191029_00056.jpg

View looking downstream waterside at the well maintained vegetation, Fall 2019.

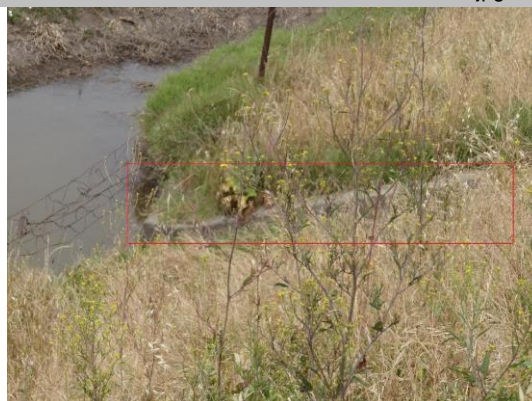
Photo 3 of 3 : UCIP_FA_2019_55186_23506.jpg

LS-concrete wing/head wall on levee toe.

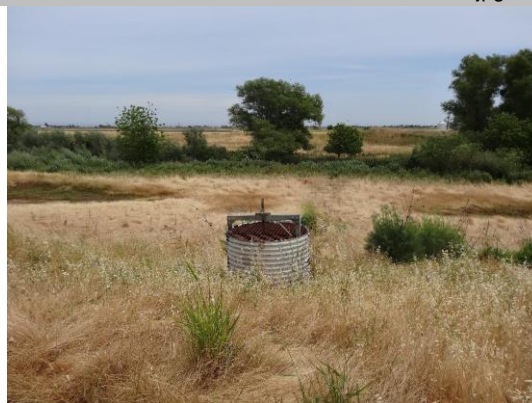
Photo 1 of 3 : UCIP_FA_2019_55187_23510.jpg

WS- slide gate in CMP riser on levee slope

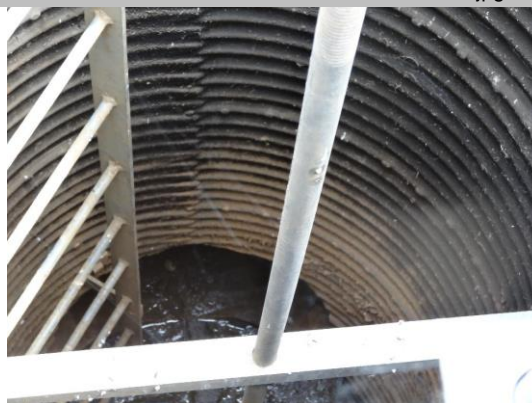
Photo 3 of 3 : UCIP_FA_2019_55199_23465.jpg

WS- pipe opening visible inside CMP riser.

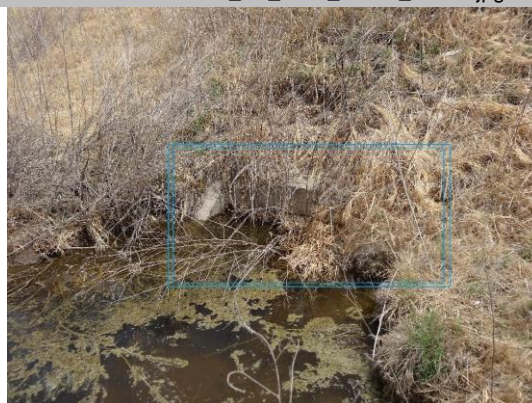
Photo 2 of 3 : UCIP_FA_2019_55196_23444.jpg

LS- concrete wing wall on levee toe

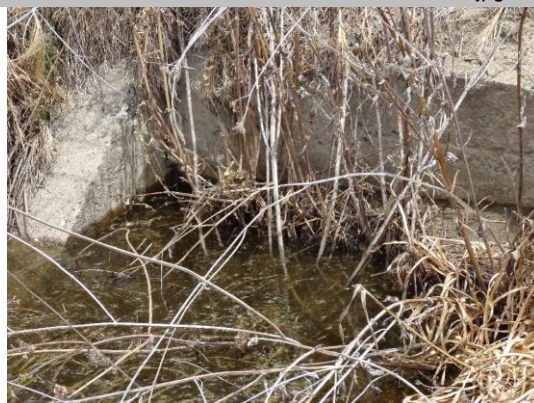
Photo 3 of 3 : UCIP_FA_2019_55196_23443.jpg

LS- pipe submerged/buried in concrete wing wall on levee toe

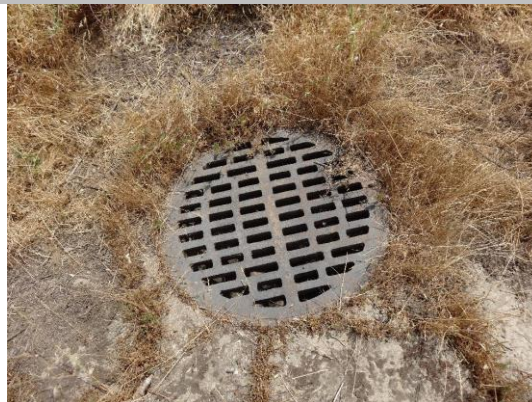
Photo 2 of 3 : UCIP_FA_2019_55203_23400.jpg

LS- a concrete box on landside toe.

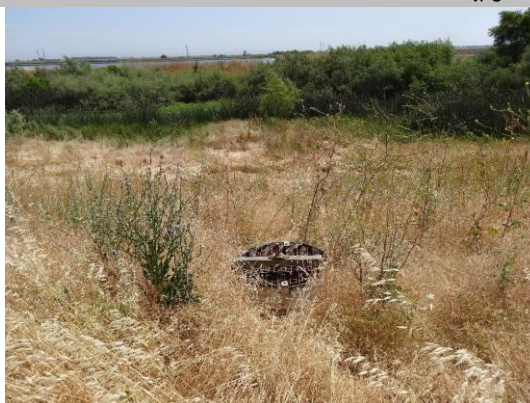
Photo 1 of 3 : UCIP_FA_2019_55205_23394.jpg

WS- slide gate in CMP riser on levee slope.

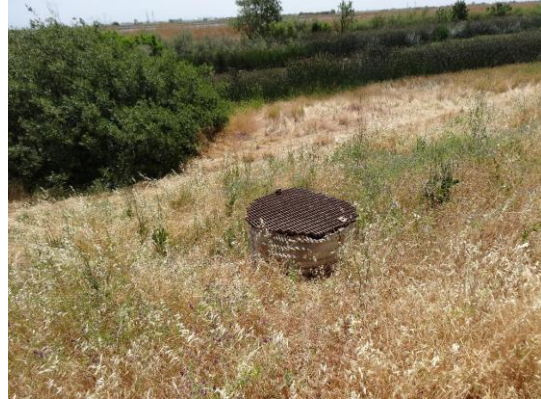
Photo 3 of 3 : UCIP_FA_2019_55206_23397.jpg

WS- slide gate in CMP riser on levee slope

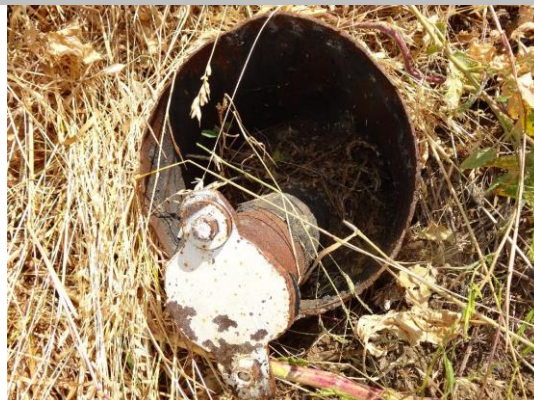
Photo 2 of 2 : UCIP_FA_2019_54565_22120.jpg

WS- gap between two pipes needs to be filled.

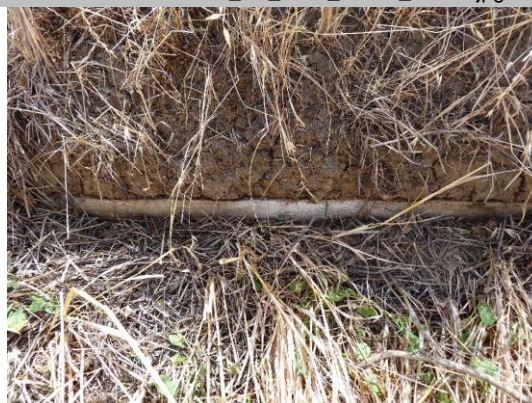
Photo 2 of 3 : UCIP_FA_2019_55208_22085.jpg

LS- almost buried concrete headwall. Only upper portion of the wall is visible.

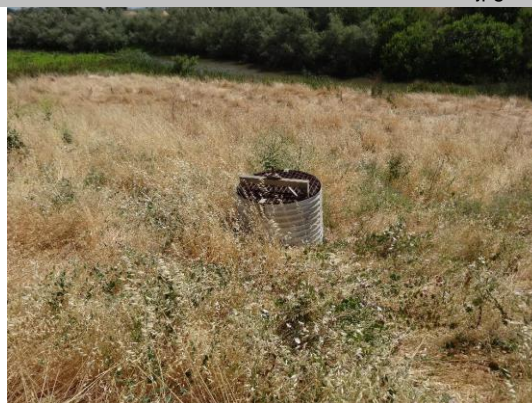
Photo 1 of 3 : UCIP_FA_2019_55209_22046.jpg

WS- slide gate, air vent in CMP riser on levee slope

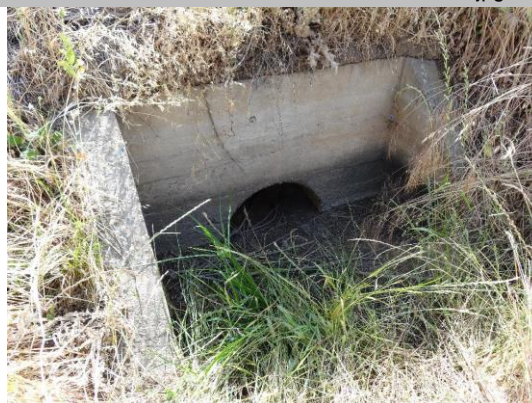
Photo 2 of 3 : UCIP_FA_2019_55209_22045.jpg

LS- CMP in concrete head/wing wall outlet

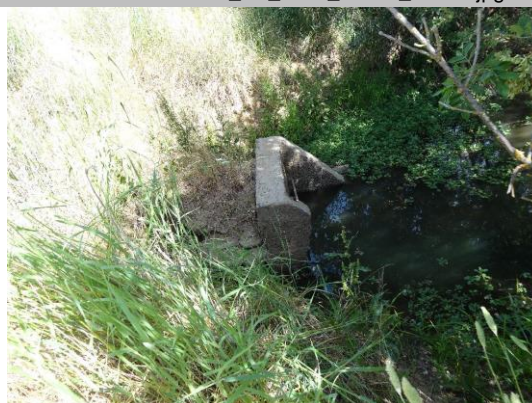
Photo 2 of 3 : UCIP_FA_2019_55210_22033.jpg

WS- inlet wing wall with trashrack

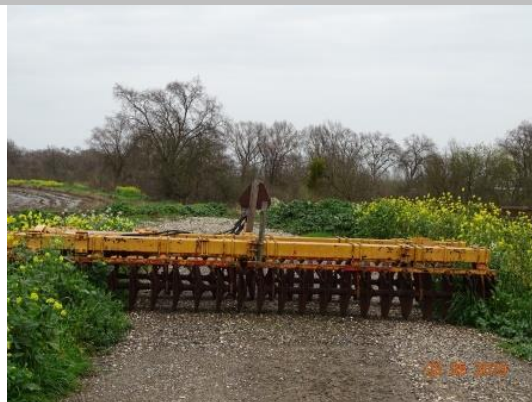
Photo 1 of 2 : FA_2019_RD1001_40_24_20190904_00008.jpg

View looking upstream on crown of a piece of equipment that prohibits access, Spring 2019.
